**Flood Control Project Maintenance  
Levee Inspections**

**Fall 2013 Levee Maintenance Deficiency Summary Report**

**Flood Control Project Maintenance  
Levee Inspections  
LMA District Cover Sheet  
Fall 2013 Levee Inspection Results**

**Reclamation District No. 0003 Grand Island**

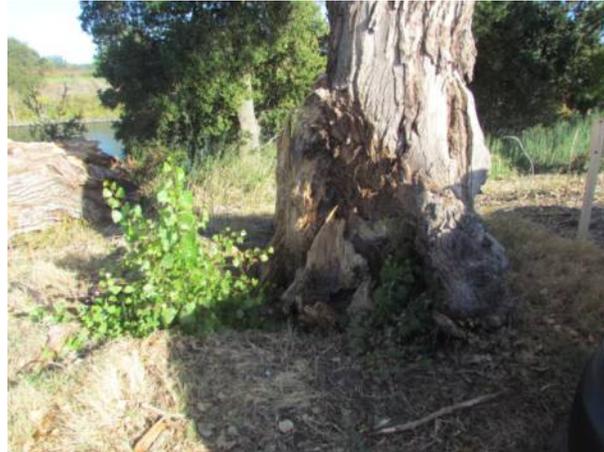
Levee Mile Report Line	4
Start Levee Mile	0.14
End Levee Mile	0.14
Location	Water Side
Category	Earthen Levee
Item	Erosion / Bank Caving
Looking west at a hole next to oak tree on waterward shoulder.	
richard_f_20131003_045.JPG

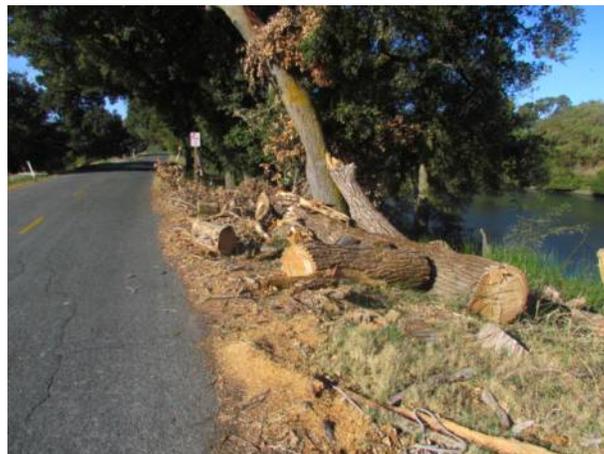
Levee Mile Report Line	5
Start Levee Mile	0.14
End Levee Mile	0.14
Location	Water Side
Category	Earthen Levee
Item	Encroachments
Looking south at tree branches on waterward shoulder.	
richard_f_20131003_047.JPG

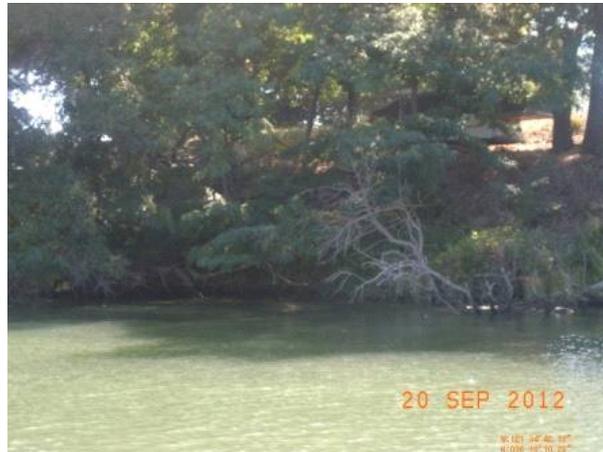
DWR ID: DWR_RD0003_01_f_2012_19										
6	0.18	0.23	Supplemental	USACE Erosion Survey	WS	M Ma	Inspector Comments: 1997 - Mass failure of berm slope and wave wash erosion. Large trees on top of berm, some failed trees. New area of low rock to on the upstream end. 2000 - Some minor erosion near the downstream end. 2005 - One new small tree has fallen. 2009 - Minimal new erosion. 2010 - Minor new erosion. 2012: No observed change. [2012 Site ID: STM_26-0_L]	38.303035 ° -121.577357 °	38.302544 ° -121.578241 °	4 Y
DWR ID:										
7	0.21	0.21	Earthen Levee	Encroachments	WS	M En	GA : Garbage Inspector Comments: Landowner has piled wooden boards and trash on waterside berm.	38.302625 ° -121.577683 °	38.302625 ° -121.577683 °	188 Y
DWR ID: DWR_RD0003_01_s_2012_188										
8	0.22	0.33	Earthen Levee	Vegetation	WS	U En	V6 : Landscaping	38.302530 ° -121.577848 °	38.301424 ° -121.579113 °	6 Y
DWR ID: DWR_RD0003_01_s_2012_6

Levee Mile Report Line	6
Start Levee Mile	0.18
End Levee Mile	0.23
Location	Water Side
Category	Supplemental
Item	USACE Erosion Survey
USACE 2012 Photo #2	
USACE2013_STM_26-0_L_2.jpg

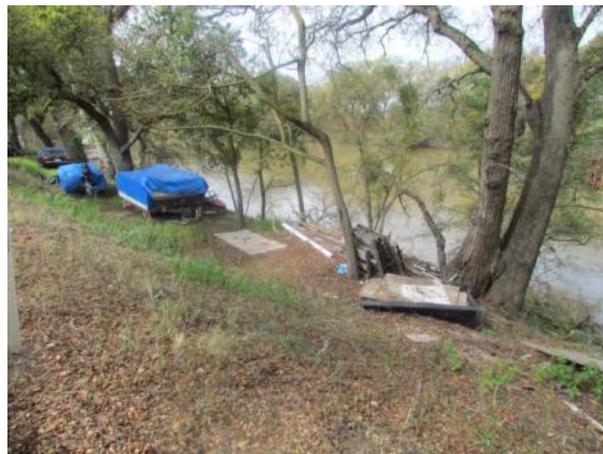
Levee Mile Report Line	7
Start Levee Mile	0.21
End Levee Mile	0.21
Location	Water Side
Category	Earthen Levee
Item	Encroachments
Looking southwest at trash on waterside berm.	
richard_f_20130918_143.jpg

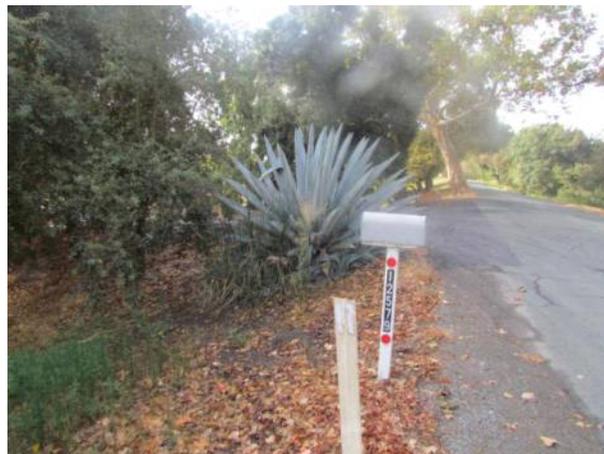
Levee Mile Report Line	10
Start Levee Mile	0.46
End Levee Mile	0.46
Location	Land Side
Category	Earthen Levee
Item	Vegetation
Looking southeast at century plant on landside shoulder.	
richard_f_20130918_092.JPG

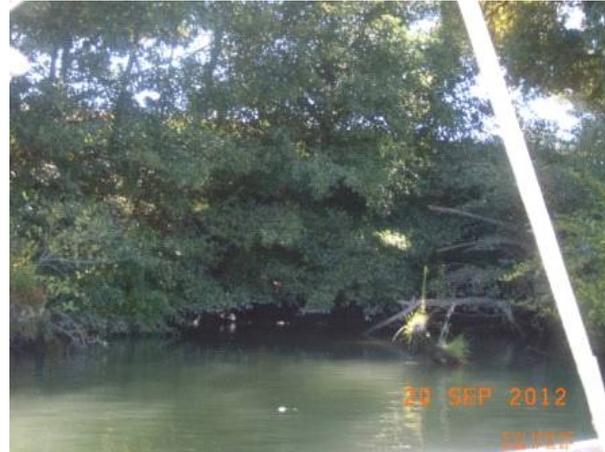
USACE 2012 Photo #1

LMIR No.	Levee Mile		Category	Item	Location	Rating	Action/Comment	GPS Latitude/Longitude		Issue No. Photo
	Start	End						Start	End	
12	0.92	1.01	Supplemental	USACE Erosion Survey	WS	M Ma	Inspector Comments: 1997 - Erosion of sandy levee on top left bank. Site is downstream of a rock section. Large riparian trees on the bank. 1999 - Upstream half of the reach repaired with rock, except for a 30 ft reach at the upstream end. 2001 - Rock repair on the upstream and downstream ends; no revetment at the trees. 2002 - Rock repair is starting to slide off the geotextile at the upstream end. 2005 - One new small tree has fallen. 2006 - 50 ft pocket at the downstream end and at the upstream end with new rock in between. 2007 - Upstream end has been repaired. 2010 - Some minor new erosion. 2011 - Minor new erosion. 2012: Minor new erosion at the toe. [2012 Site ID: STM_25-0_L]	38.293386 ° -121.582554 °	38.292675 ° -121.582741 °	10 Y

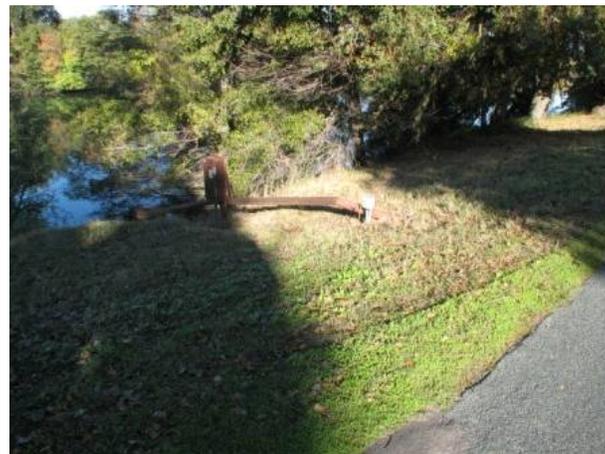
Irrigation intake pipe from Steamboat Slough.

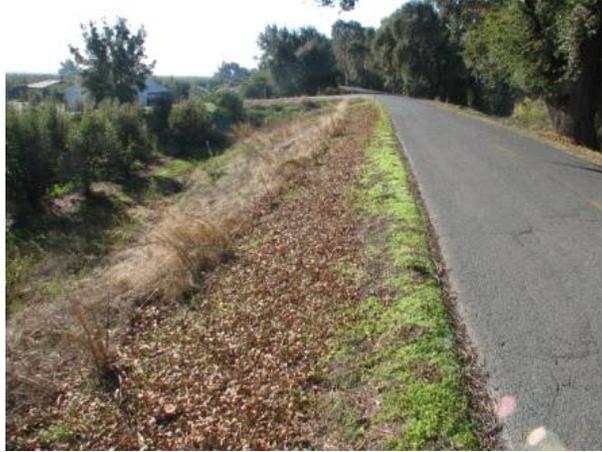
Levee Mile Report Line	14
Start Levee Mile	1.01
End Levee Mile	1.03
Location	Land Side
Category	Earthen Levee
Item	Vegetation
Grass on levee slope and toe exceeds 12" and partially obstructs visibility.	
richard_f_20130918_105.jpg

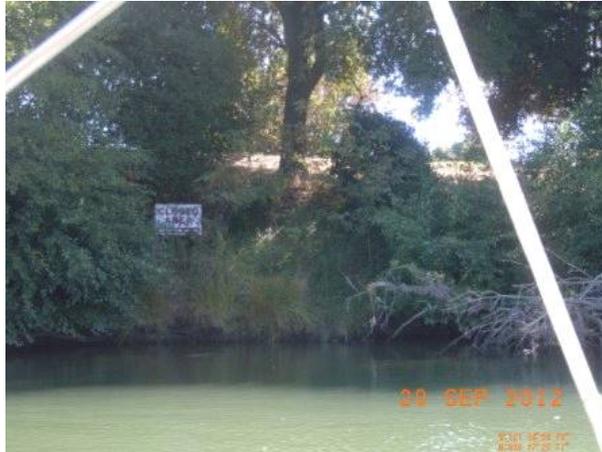
Levee Mile Report Line	15
Start Levee Mile	1.03
End Levee Mile	1.18
Location	Water Side
Category	Supplemental
Item	USACE Erosion Survey
USACE 2012 Photo #1	
USACE2013_STM_24-8_L_1.jpg

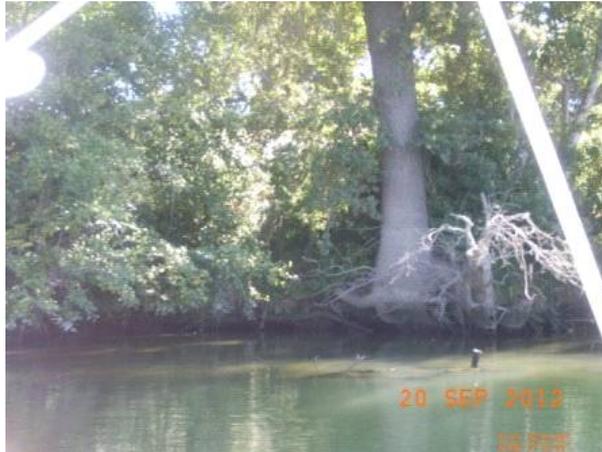
Levee Mile Report Line	15
Start Levee Mile	1.03
End Levee Mile	1.18
Location	Water Side
Category	Supplemental
Item	USACE Erosion Survey
USACE 2012 Photo #2	
USACE2013_STM_24-8_L_2.jpg

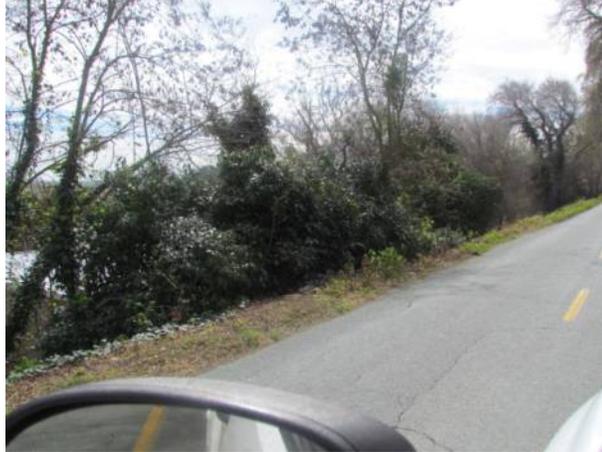
Levee Mile Report Line	16
Start Levee Mile	1.08
End Levee Mile	1.09
Location	Land Side
Category	Earthen Levee
Item	Vegetation
Looking southeast at landscaping on landside slope.	
richard_f_20130918_082.jpg

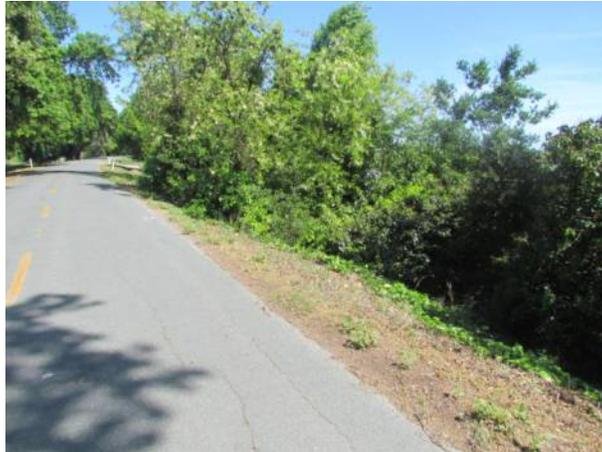
Levee Mile Report Line	16
Start Levee Mile	1.08
End Levee Mile	1.09
Location	Land Side
Category	Earthen Levee
Item	Vegetation
Looking northeast at dense landscape on landward slope. (Spring 2013)	
richard_f_20130918_083.JPG

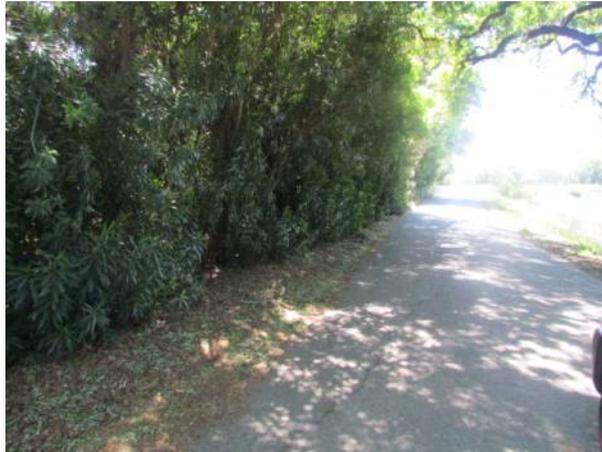
Levee Mile Report Line	17
Start Levee Mile	1.21
End Levee Mile	1.27
Location	Land Side
Category	Earthen Levee
Item	Vegetation
Looking southeast at dense landscape (Oleanders) on landward shoulder and slope.	
richard_f_20130918_090.JPG

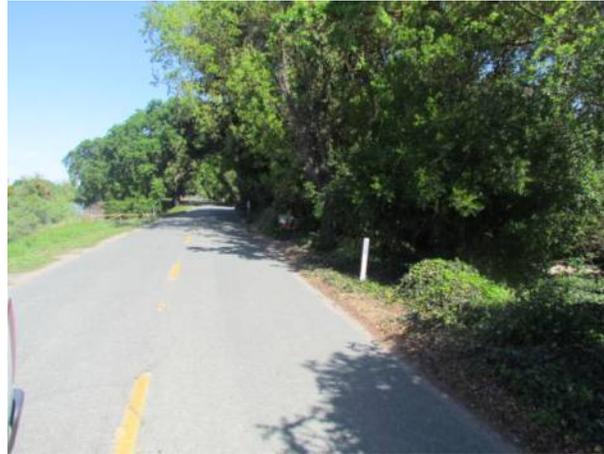
Looking north at dense landscaping on landward shoulder and slope.

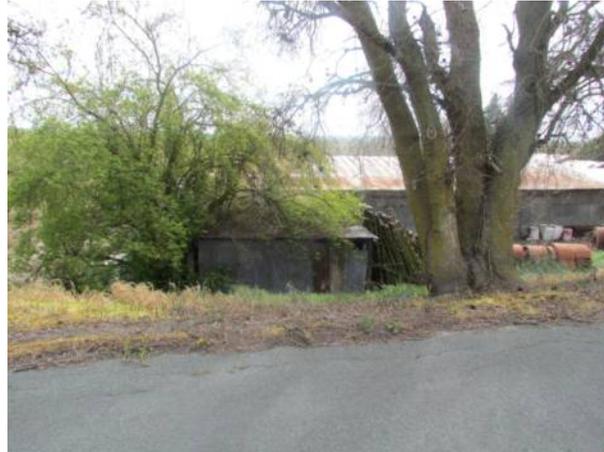
Levee Mile Report Line	20
Start Levee Mile	1.40
End Levee Mile	1.40
Location	Land Side
Category	Earthen Levee
Item	Encroachments
Looking east at tool shed and equipment on landside toe.	
richard_f_20130918_108.jpg

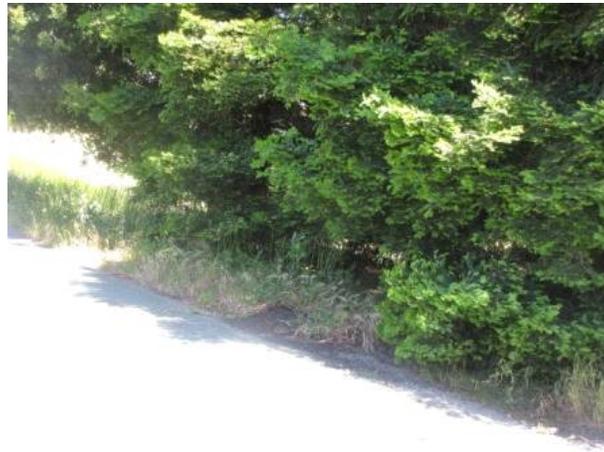
Levee Mile Report Line	21
Start Levee Mile	1.60
End Levee Mile	1.60
Location	Land Side
Category	Earthen Levee
Item	Vegetation
Looking southeast at dense trees on landside shoulder and slope.	
richard_f_20130918_086.jpg

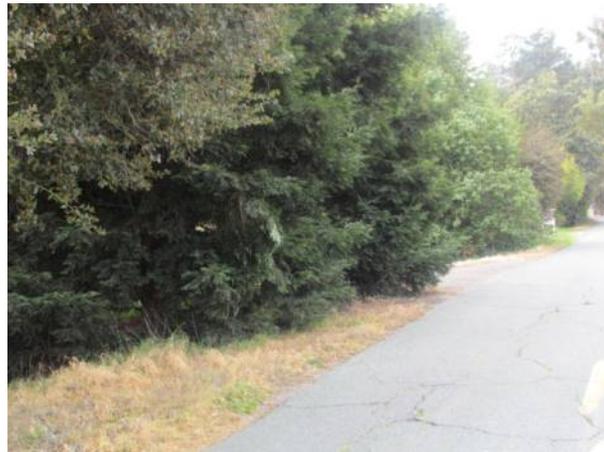
Levee Mile Report Line	21
Start Levee Mile	1.60
End Levee Mile	1.60
Location	Land Side
Category	Earthen Levee
Item	Vegetation
Looking southeast at dense trees on landside shoulder and slope. (updated Spring 2012)	
richard_f_20130918_087.jpg

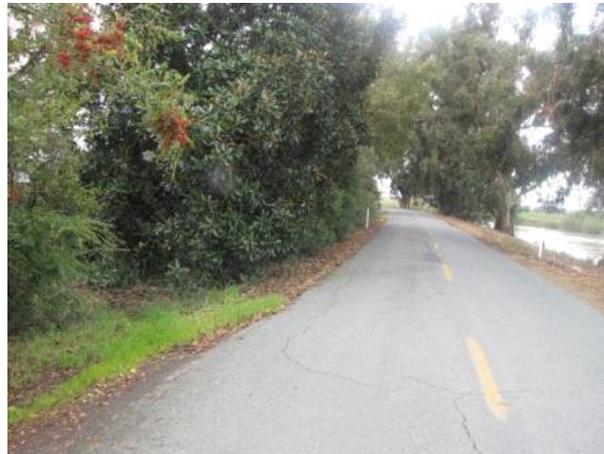
Levee Mile Report Line	24
Start Levee Mile	1.64
End Levee Mile	1.66
Location	Land Side
Category	Earthen Levee
Item	Vegetation
Looking southwest at dense landscaping on landside shoulder and slope.	
richard_f_20130918_088.jpg

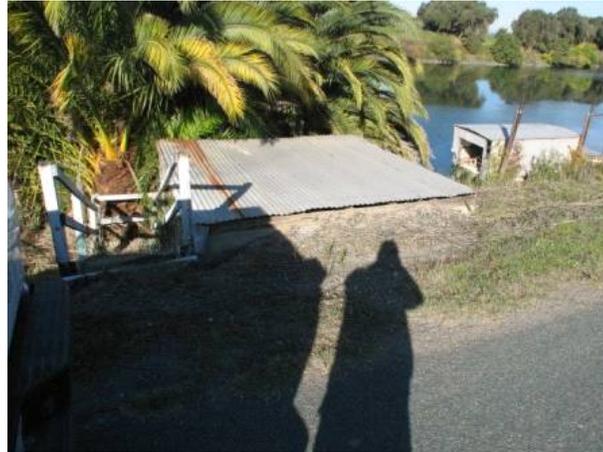
Levee Mile Report Line	28
Start Levee Mile	2.07
End Levee Mile	2.07
Location	Water Side
Category	Earthen Levee
Item	Encroachments
Pipe penetration and pump shed on waterside slope.	
richard_f_20130918_109.jpg

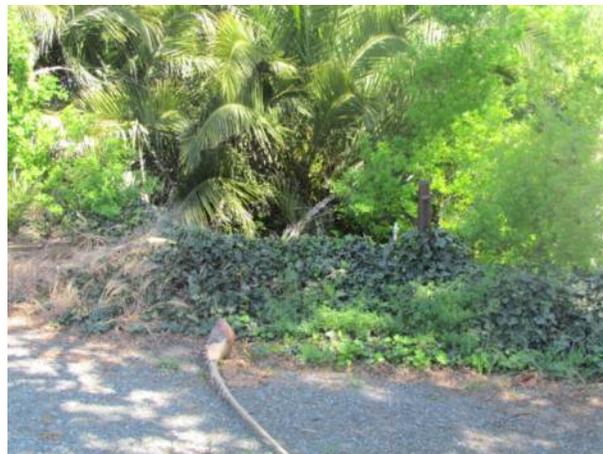
Levee Mile Report Line	31
Start Levee Mile	2.39
End Levee Mile	2.39
Location	Land Side
Category	Earthen Levee
Item	Vegetation
Looking east at dense landscaping on landward slope.	
richard_f_20130918_098.JPG

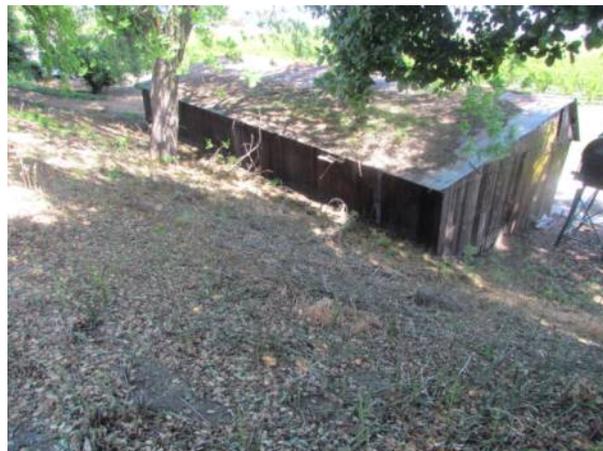
Levee Mile Report Line	32
Start Levee Mile	2.43
End Levee Mile	2.43
Location	Land Side
Category	Earthen Levee
Item	Encroachments
Looking northeast at storage shed at landward toe.	
richard_f_20130918_102.JPG

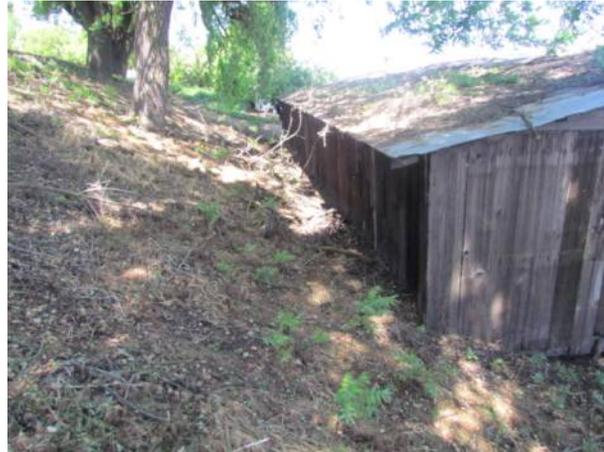
Levee Mile Report Line	32
Start Levee Mile	2.43
End Levee Mile	2.43
Location	Land Side
Category	Earthen Levee
Item	Encroachments
Looking north at storage shed at landward toe.	
richard_f_20130918_103.JPG

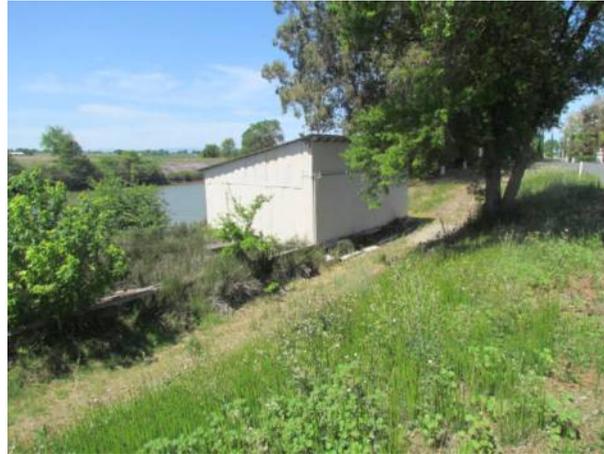
Looking northwest at storage shed on waterward berm.

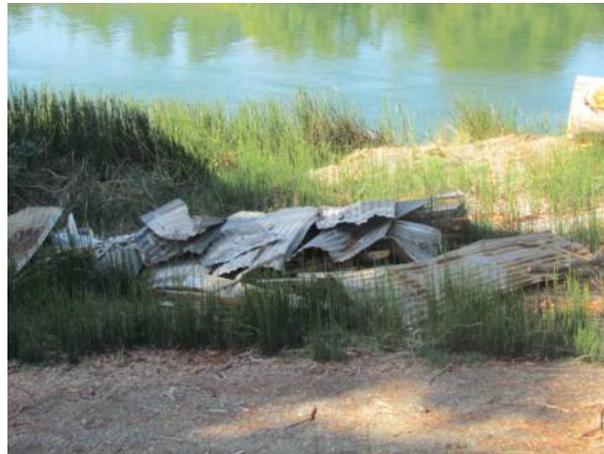
Levee Mile Report Line	40
Start Levee Mile	2.89
End Levee Mile	2.89
Location	Water Side
Category	Earthen Levee
Item	Encroachments

Looking west a tin roofing material on waterward berm.

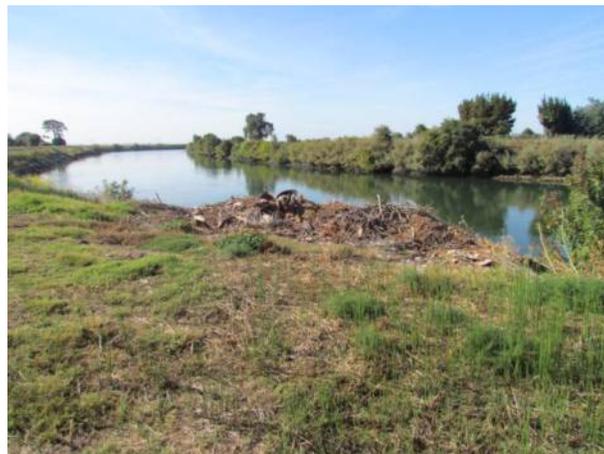
Levee Mile Report Line	41
Start Levee Mile	2.93
End Levee Mile	2.93
Location	Water Side
Category	Earthen Levee
Item	Encroachments

Looking southwest at grass clippings on waterward berm.

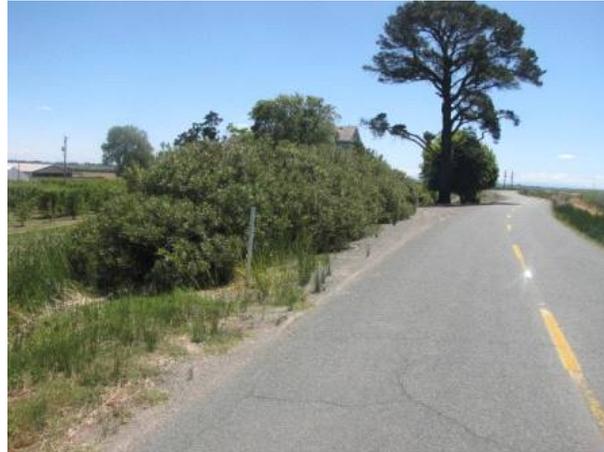
Levee Mile Report Line	44
Start Levee Mile	3.13
End Levee Mile	3.15
Location	Land Side
Category	Earthen Levee
Item	Vegetation
Looking northeast at dense veg. on landside slope.	
richard_f_20130918_089.jpg

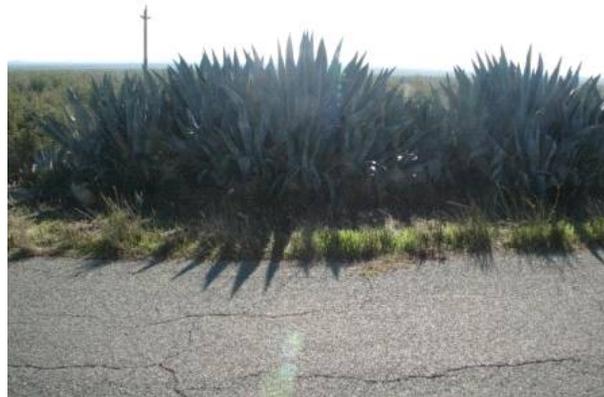
Levee Mile Report Line	47
Start Levee Mile	3.33
End Levee Mile	3.33
Location	Land Side
Category	Earthen Levee
Item	Vegetation
Large cactus on upper levee slope obstructs access and visibility.	
richard_f_20130918_115.jpg

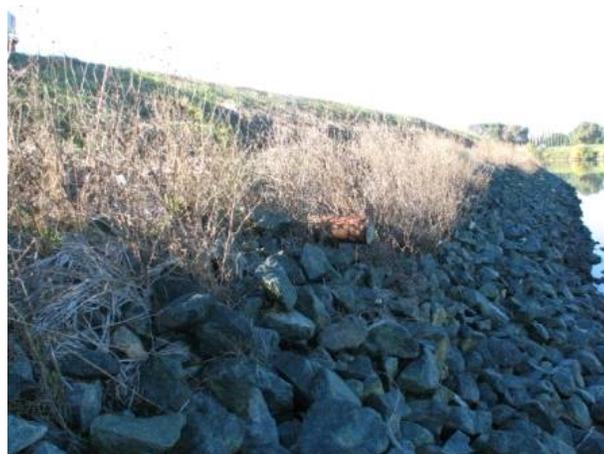
Levee Mile Report Line	48
Start Levee Mile	3.52
End Levee Mile	3.52
Location	Crown
Category	Earthen Levee
Item	Encroachments
Abandoned pipe penetration. Pipe has been grouted.	
richard_f_20130918_116.jpg

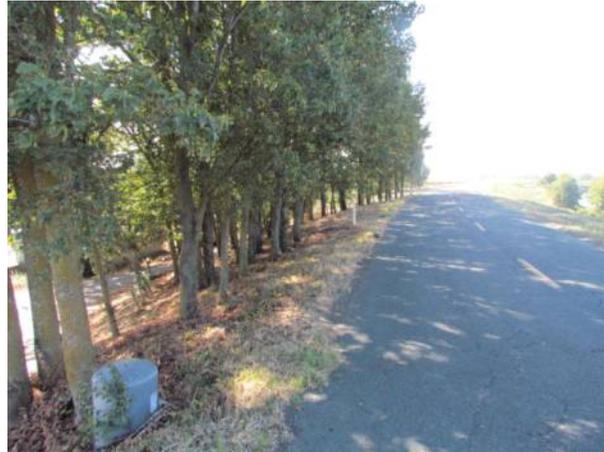
richard\_f\_20131003\_052.JPG

Looking southeast at trees on landward shoulder and slope.

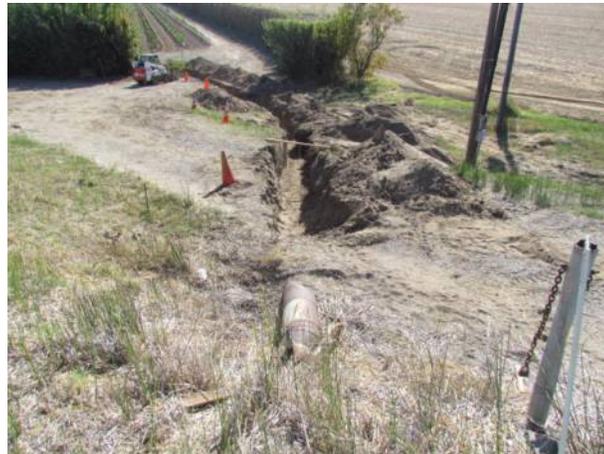
richard\_f\_20131003\_053.JPG

Looking east at a trench on landward slope and berm.

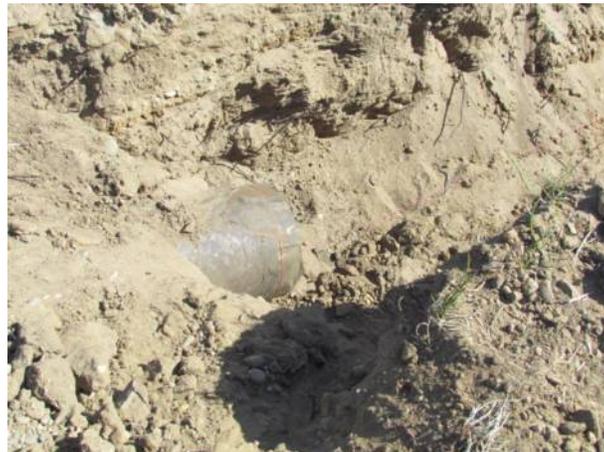
richard\_f\_20131003\_054.JPG

Looking north at a cut-off steel pipe in trench on landward slope.

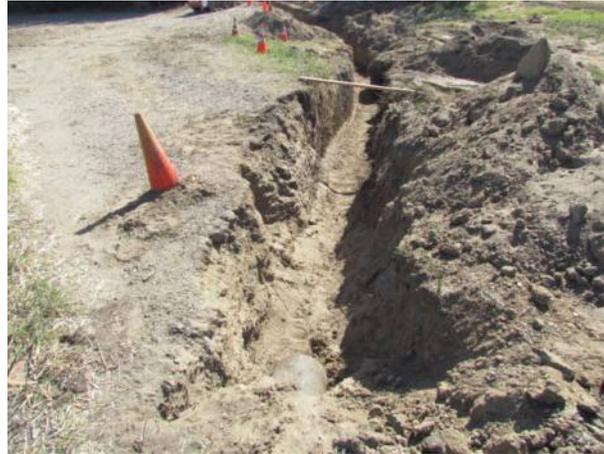
richard\_f\_20131003\_055.JPG

Looking east at a trench on landward slope.

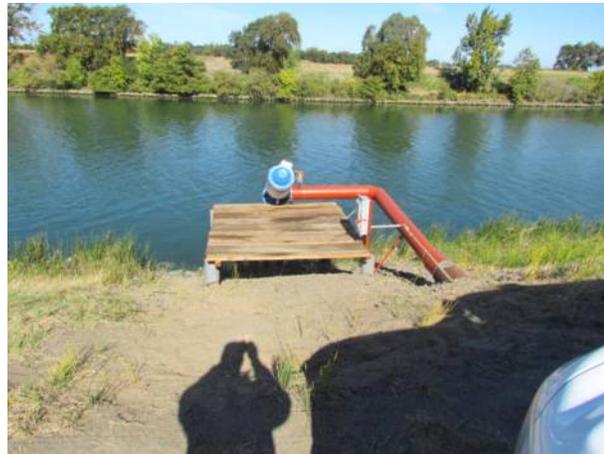
richard\_f\_20131003\_056.JPG

Looking west at a new pump and pipe on waterward slope.

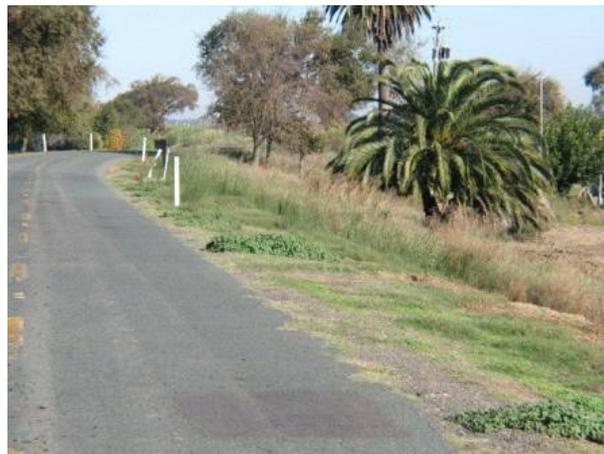
richard\_f\_20130918\_117.jpg

Vegetation on levee slopes and toe partially obstruct visibility.

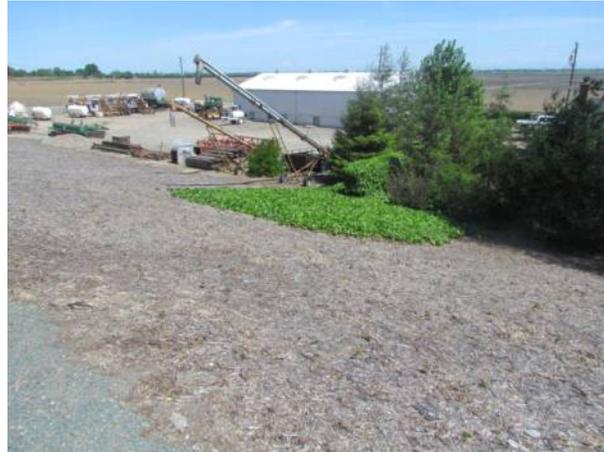
Levee Mile Report Line	57
Start Levee Mile	4.79
End Levee Mile	4.79
Location	Land Side
Category	Earthen Levee
Item	Vegetation
Looking northeast at landscaping at lower half of landward slope and toe.	
richard_f_20130918_114.JPG

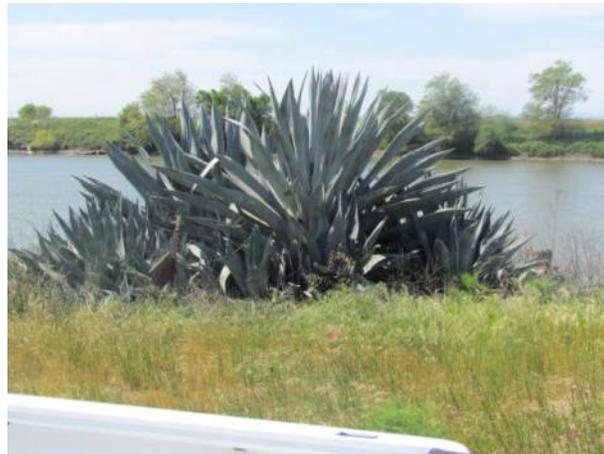
Levee Mile Report Line	58
Start Levee Mile	5.11
End Levee Mile	5.11
Location	Water Side
Category	Earthen Levee
Item	Vegetation
Looking west at century plant on waterward slope.	
richard_f_20130918_118.JPG

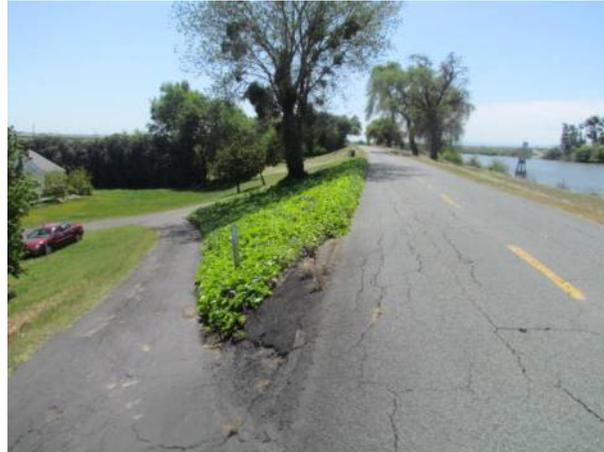
Levee Mile Report Line	61
Start Levee Mile	5.37
End Levee Mile	5.40
Location	Land Side
Category	Earthen Levee
Item	Vegetation
Looking southeast at ground cover on landward slope.	
richard_f_20130918_110.JPG

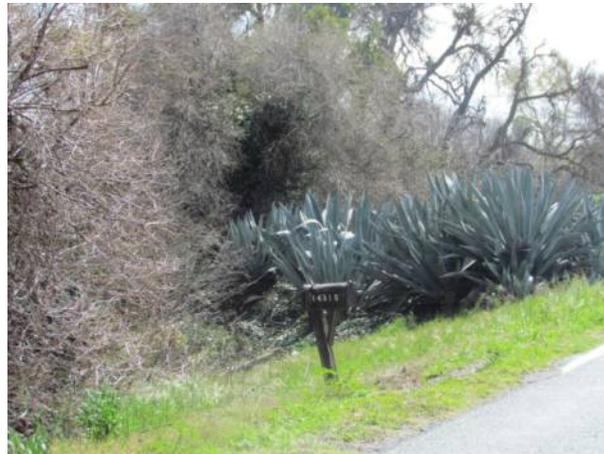
Levee Mile Report Line	62
Start Levee Mile	5.48
End Levee Mile	5.50
Location	Land Side
Category	Earthen Levee
Item	Vegetation
Looking southeast at century plants on landside shoulder and slope.	
richard_f_20130918_111.jpg

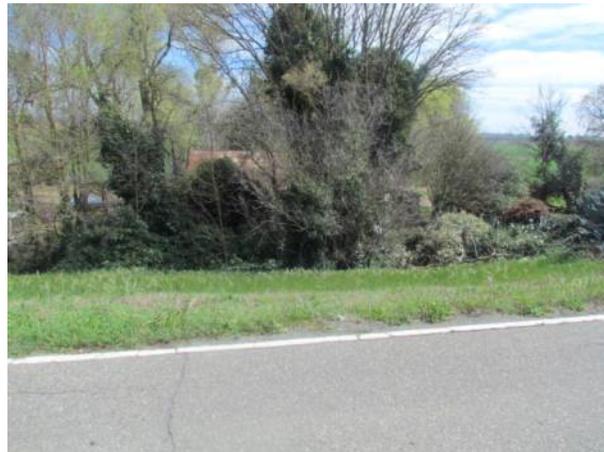
Levee Mile Report Line	63
Start Levee Mile	5.53
End Levee Mile	5.53
Location	Land Side
Category	Earthen Levee
Item	Vegetation
Looking east at landscaping on landside toe.	
richard_f_20130918_112.jpg

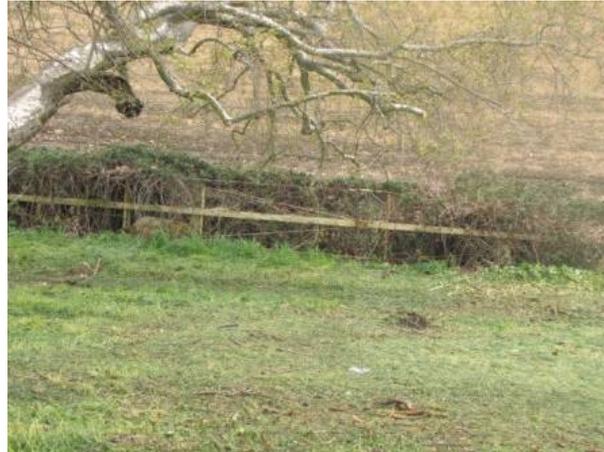
Levee Mile Report Line	65
Start Levee Mile	5.70
End Levee Mile	5.70
Location	Land Side
Category	Earthen Levee
Item	Encroachments
Looking east at dense vegetation covering farm equipment on landside toe.	
richard_f_20130918_120.jpg

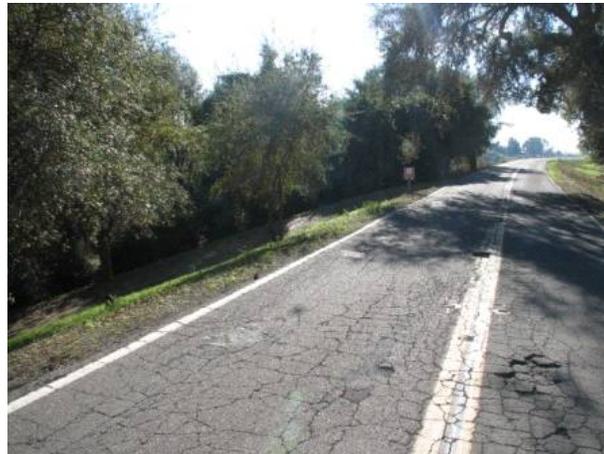
Levee Mile Report Line	66
Start Levee Mile	5.76
End Levee Mile	5.76
Location	Land Side
Category	Earthen Levee
Item	Vegetation
Landscaping on levee slope and within 10' of levee toe obstruct visibility and access.	
richard_f_20130918_121.jpg

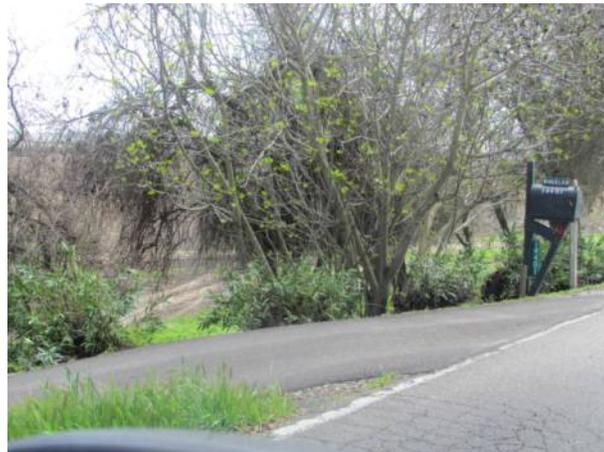
Levee Mile Report Line	66
Start Levee Mile	5.76
End Levee Mile	5.76
Location	Land Side
Category	Earthen Levee
Item	Vegetation
Looking southeast at trimmed landscaping on landside shoulder and slope. (Updated Spring 2012)	
richard_f_20130918_122.jpg

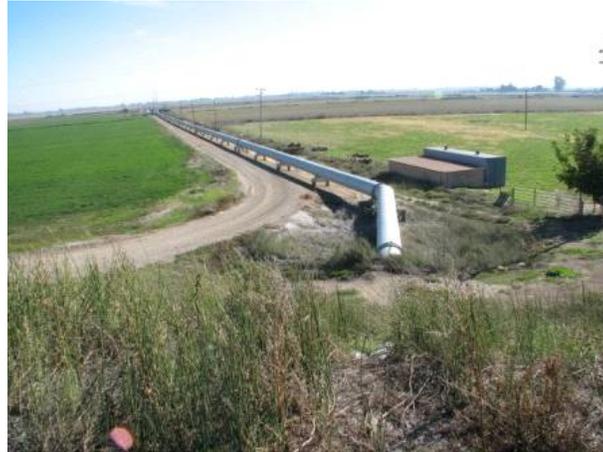
Levee Mile Report Line	71
Start Levee Mile	6.76
End Levee Mile	6.76
Location	Land Side
Category	Earthen Levee
Item	Encroachments
Interior drainage discharge pipe penetrates levee.	
richard_f_20130918_123.jpg

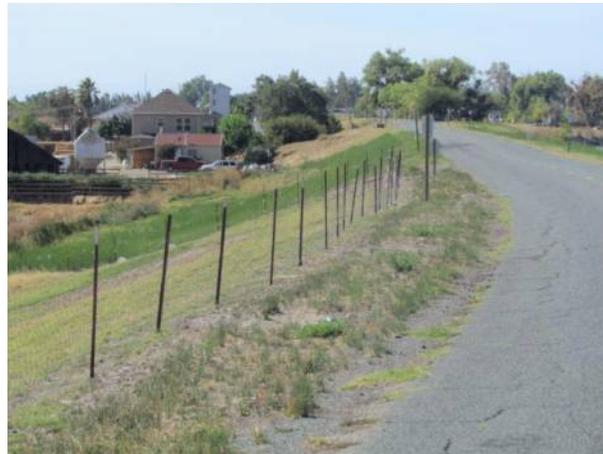
Levee Mile Report Line	72
Start Levee Mile	6.83
End Levee Mile	6.90
Location	Land Side
Category	Earthen Levee
Item	Encroachments
Looking southeast at fencing on landward shoulder and slope.	
richard_f_20131003_057.JPG

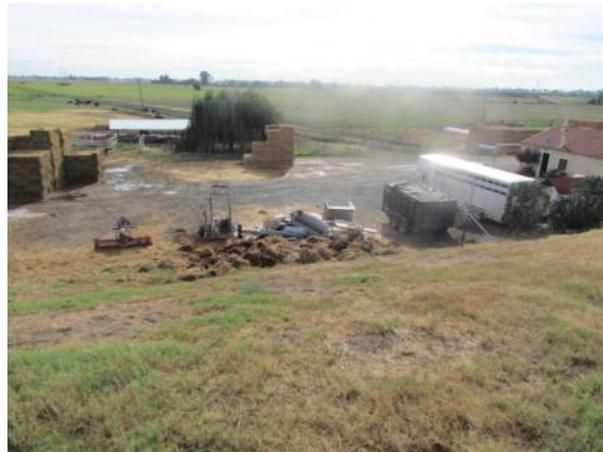
Levee Mile Report Line	74
Start Levee Mile	7.00
End Levee Mile	7.00
Location	Land Side
Category	Earthen Levee
Item	Encroachments
Looking east at garbage at landside toe.	
richard_f_20130918_096.JPG

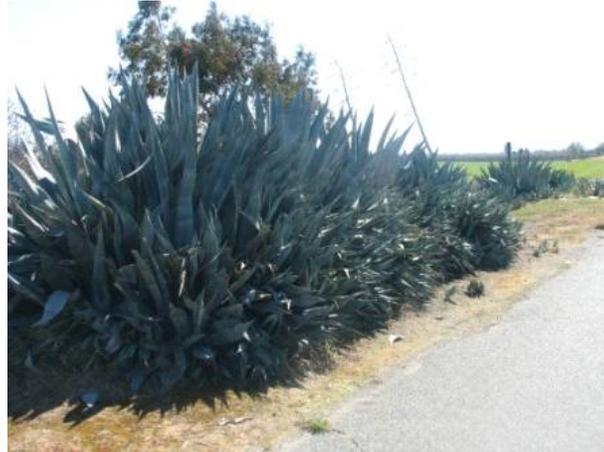
Levee Mile Report Line	77
Start Levee Mile	7.08
End Levee Mile	7.10
Location	Land Side
Category	Earthen Levee
Item	Vegetation
Large cactus plant on landside shoulder block view of levee slope from LM 7.08 to 7.10.	
richard_f_20130918_093.jpg

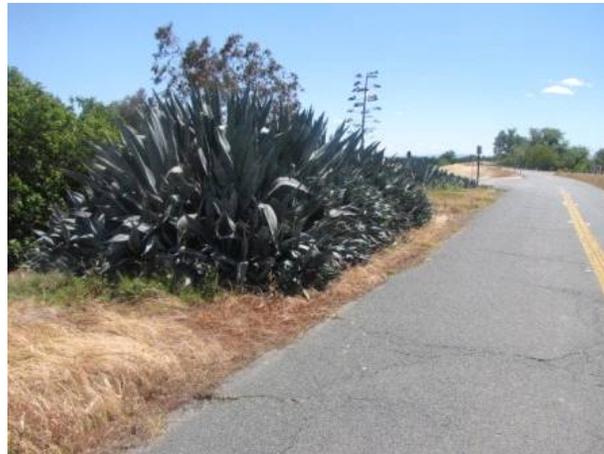
Levee Mile Report Line	77
Start Levee Mile	7.08
End Levee Mile	7.10
Location	Land Side
Category	Earthen Levee
Item	Vegetation
Looking northeast at updated picture (5/2010) of century plants on landside shoulder and slope.	
richard_f_20130918_094.jpg

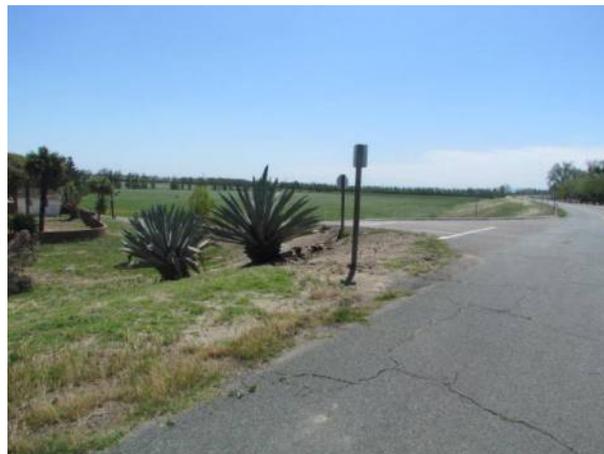
Levee Mile Report Line	77
Start Levee Mile	7.08
End Levee Mile	7.10
Location	Land Side
Category	Earthen Levee
Item	Vegetation
Looking southeast at after landowner removed cactus plant on landward shoulder.	
richard_f_20130918_095.JPG

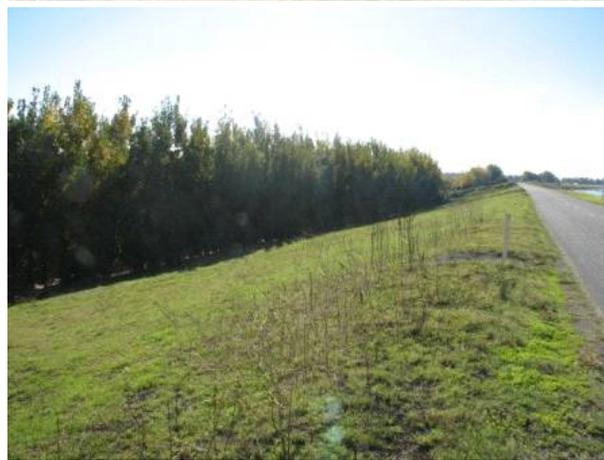
richard\_f\_20130918\_127.jpg

Trees within 10' of levee toe obstruct access and visibility of levee toe.

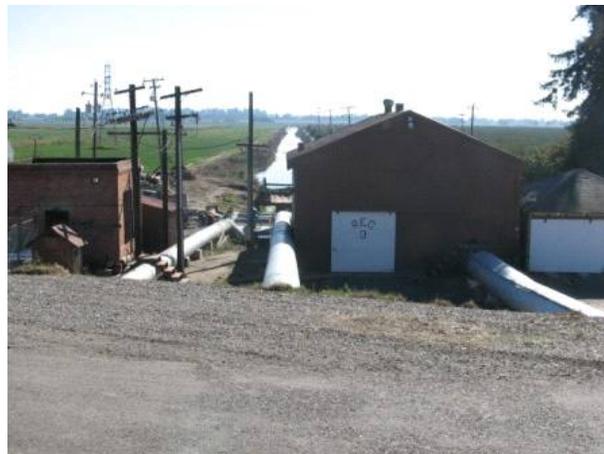
Levee Mile Report Line	95
Start Levee Mile	8.75
End Levee Mile	8.75
Location	Water Side
Category	Earthen Levee
Item	Encroachments
Interior drainage discharge pipes penetrate levee.	
richard_f_20130918_128.jpg

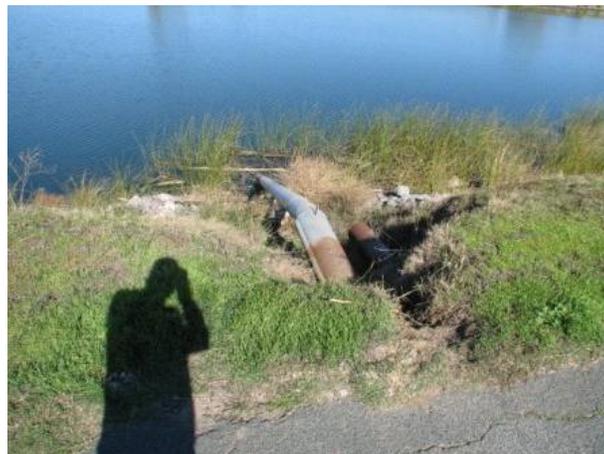
Levee Mile Report Line	99
Start Levee Mile	9.19
End Levee Mile	9.19
Location	Water Side
Category	Earthen Levee
Item	Erosion / Bank Caving
Erosion occurring around pipe penetration.	
richard_f_20130918_130.jpg

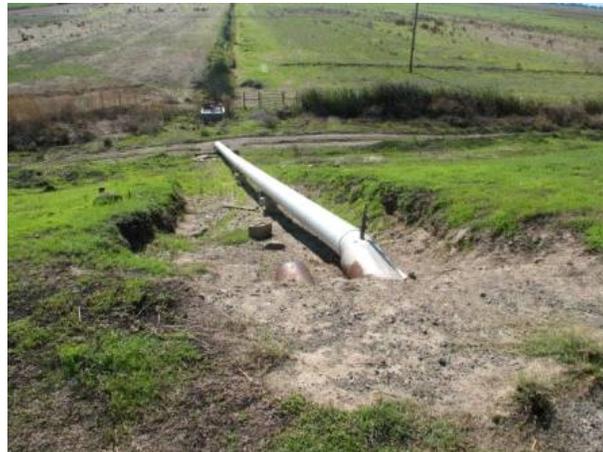
Levee Mile Report Line	100
Start Levee Mile	9.19
End Levee Mile	9.19
Location	Water Side
Category	Earthen Levee
Item	Encroachments
Pipe penetration showing newer pipe next to abandoned pipe.	
richard_f_20130918_129.jpg

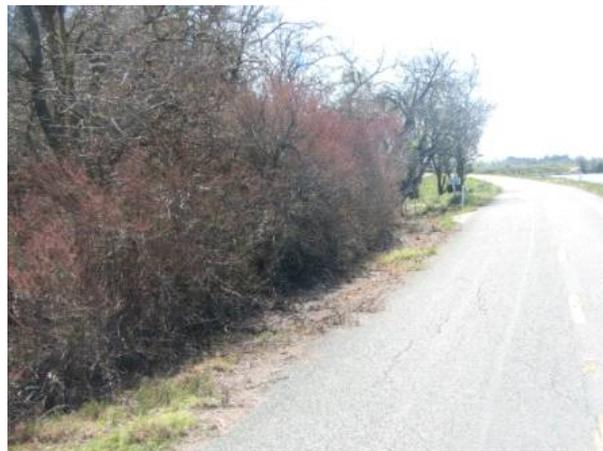
Levee Mile Report Line	102
Start Levee Mile	10.20
End Levee Mile	10.22
Location	Land Side
Category	Earthen Levee
Item	Trim / Thin Trees
Trees to be trimmed on landside shoulder from LM 10.20 to 10.22	
richard_f_20130918_099.jpg

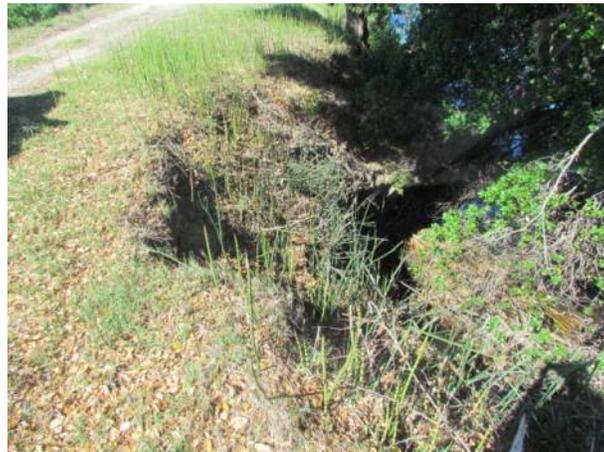
Levee Mile Report Line	106
Start Levee Mile	10.83
End Levee Mile	10.83
Location	Water Side
Category	Earthen Levee
Item	Erosion / Bank Caving

Looking southwest at erosion on waterward slope.

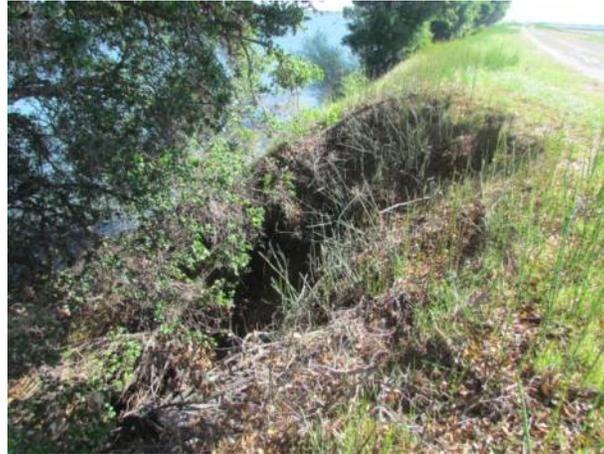
richard\_f\_20130918\_134.JPG

Looking northwest at erosion on waterward slope.

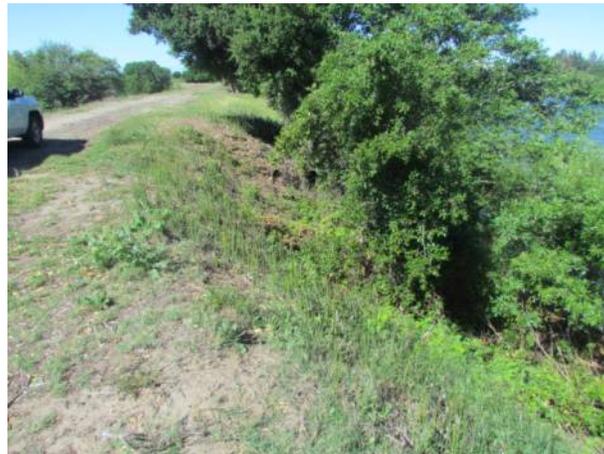
richard\_f\_20130918\_136.JPG

Looking south at erosion on waterward slope.

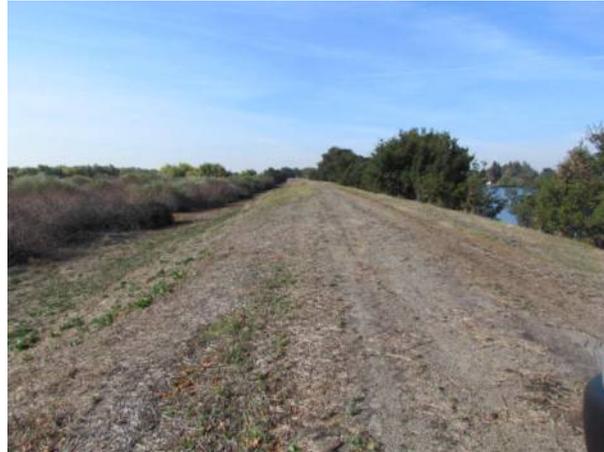
Levee Mile Report Line	108
Start Levee Mile	10.87
End Levee Mile	11.01
Location	Land Side
Category	Earthen Levee
Item	Vegetation
Looking south at typical view of levee between levee mile 10.87 to 11.01	
richard_f_20130918_132.jpg

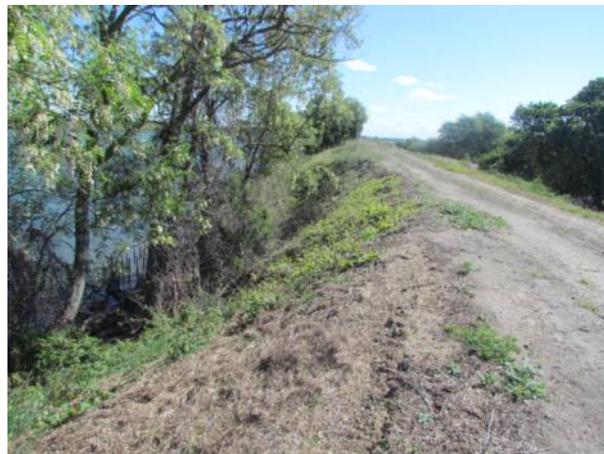
Levee Mile Report Line	109
Start Levee Mile	10.95
End Levee Mile	10.97
Location	Water Side
Category	Earthen Levee
Item	Erosion / Bank Caving
Looking north at erosion on waterward slope.	
richard_f_20130918_137.JPG

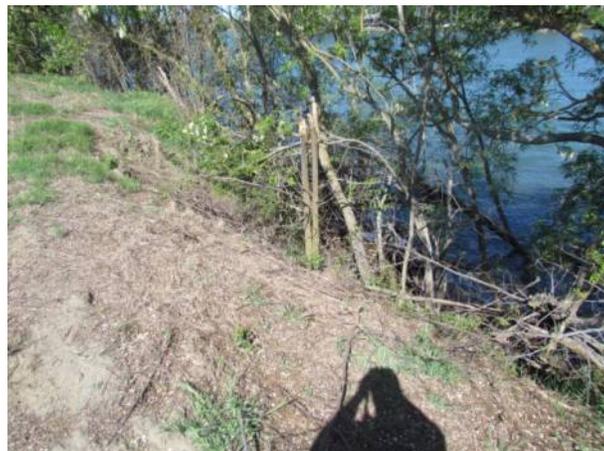
Levee Mile Report Line	109
Start Levee Mile	10.95
End Levee Mile	10.97
Location	Water Side
Category	Earthen Levee
Item	Erosion / Bank Caving
Looking west at erosion on waterward slope.	
richard_f_20130918_138.JPG

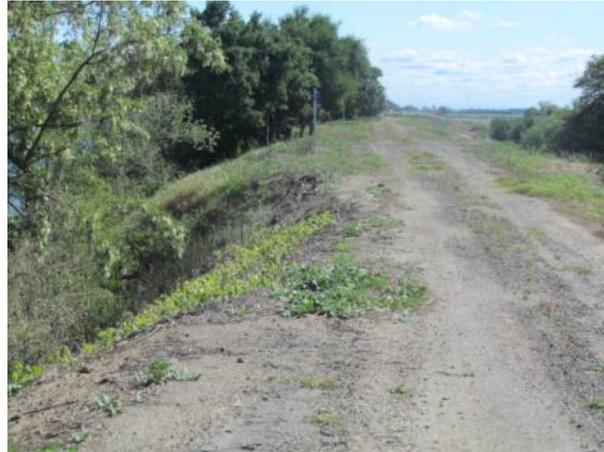
Levee Mile Report Line	109
Start Levee Mile	10.95
End Levee Mile	10.97
Location	Water Side
Category	Earthen Levee
Item	Erosion / Bank Caving
Looking northwest at erosion on waterward shoulder and slope.	
richard_f_20130918_139.JPG

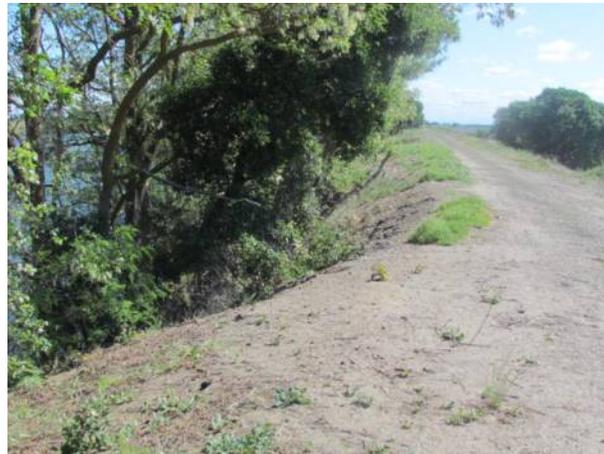
Levee Mile Report Line	110
Start Levee Mile	11.00
End Levee Mile	11.02
Location	Water Side
Category	Earthen Levee
Item	Erosion / Bank Caving
Looking north at erosion on waterward shoulder and slope.	
richard_f_20130918_140.JPG

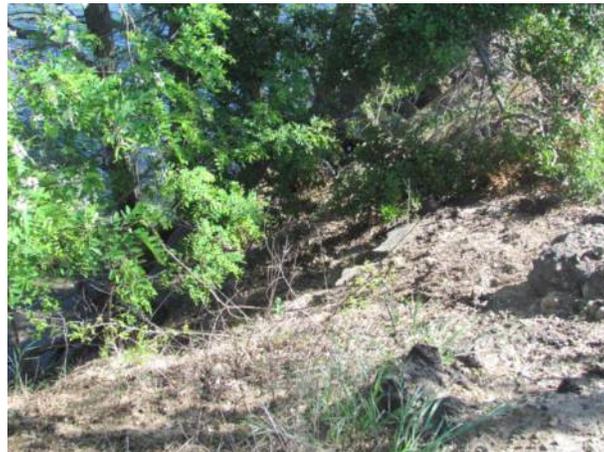
Levee Mile Report Line	110
Start Levee Mile	11.00
End Levee Mile	11.02
Location	Water Side
Category	Earthen Levee
Item	Erosion / Bank Caving
Looking west at erosion on waterward slope.	
richard_f_20130918_141.JPG

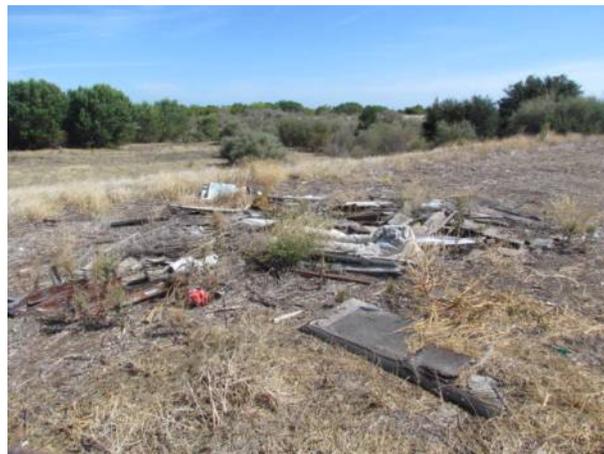
Levee Mile Report Line	3
Start Levee Mile	0.09
End Levee Mile	0.09
Location	Land Side
Category	Earthen Levee
Item	Encroachments

Looking northwest at garbage on landward slope.

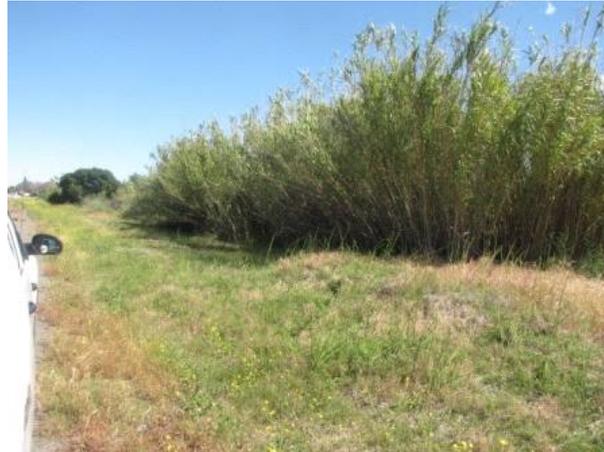
Levee Mile Report Line	6
Start Levee Mile	0.31
End Levee Mile	0.33
Location	Water Side
Category	Earthen Levee
Item	Vegetation
Looking northeast at bamboo on waterside slope.	
richard_f_20130918_150.jpg

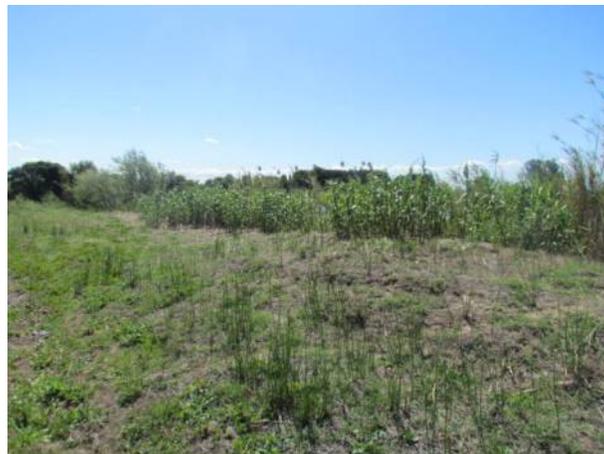
Levee Mile Report Line	6
Start Levee Mile	0.31
End Levee Mile	0.33
Location	Water Side
Category	Earthen Levee
Item	Vegetation
Looking northeast at the new sprouting of bamboo on waterward slope.	
richard_f_20130918_151.JPG

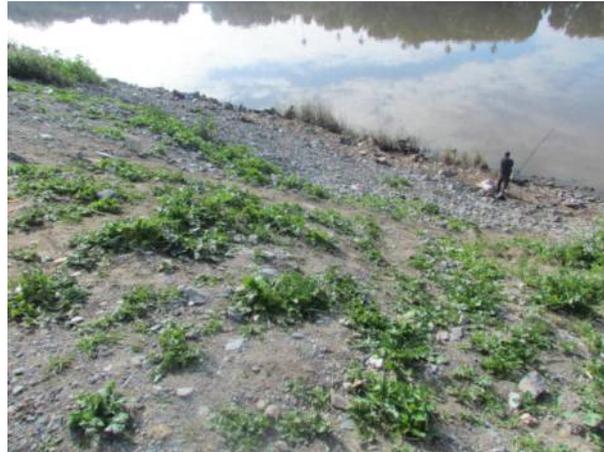
richard\_f\_20130918\_147.jpg

Slope instability caused by foot traffic on levee slope.

Looking east at repaired slope damage caused by foot traffic.

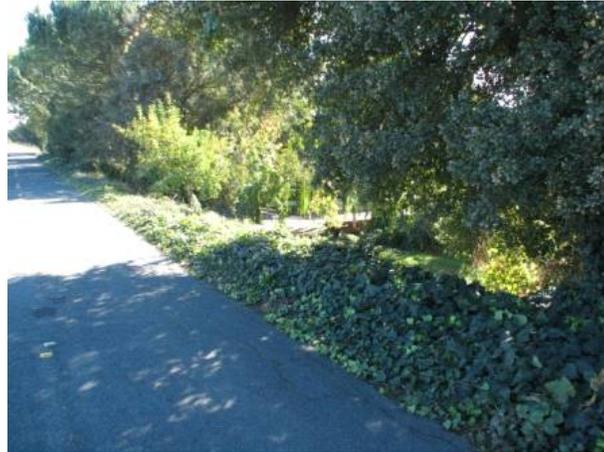
Levee Mile Report Line	13
Start Levee Mile	1.93
End Levee Mile	1.98
Location	Water Side
Category	Earthen Levee
Item	Vegetation
Landscaping on levee slope obstructs visibility and access.	
richard_f_20130918_187.jpg

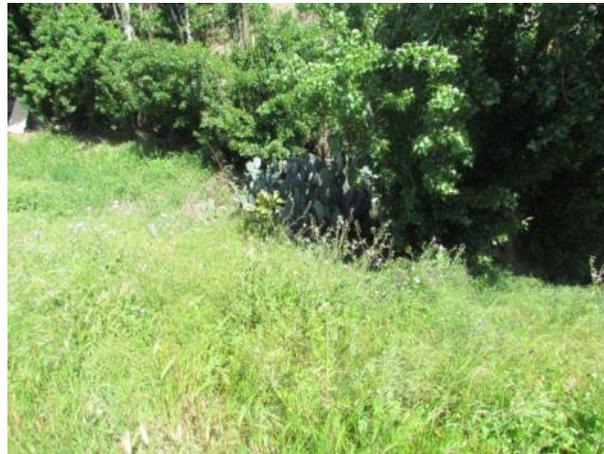
Levee Mile Report Line	15
Start Levee Mile	2.50
End Levee Mile	2.50
Location	Land Side
Category	Earthen Levee
Item	Vegetation
Looking northwest at dense vegetation on landward slope.	
richard_f_20130918_192.JPG
